9. Levee Maintaining Agency Projects

9.1. Overview

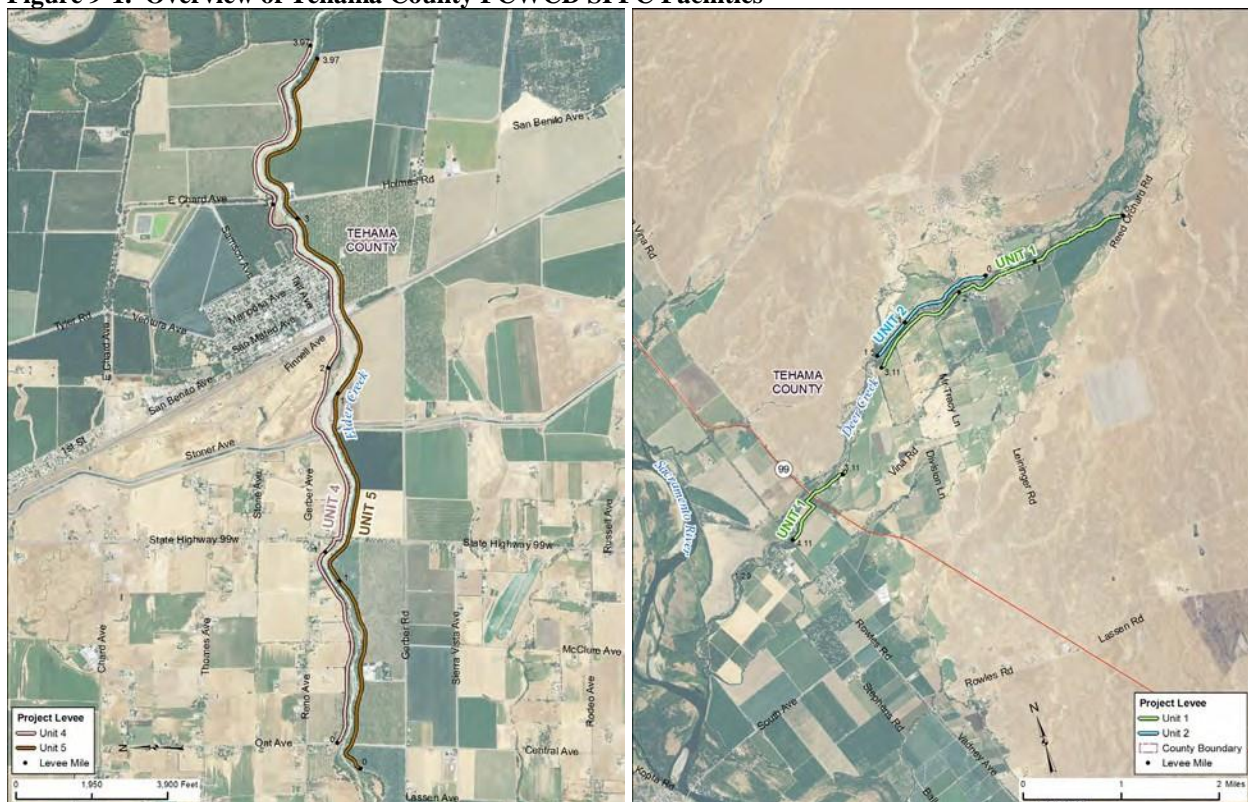
Figure 9-1. Overview of Tehama County FCWCD SPFC Facilities

Tehama County Flood Control & Water Conservation District (FCWCD) was originally established in 1957 by the Tehama County Flood Control and Water Conservation District Act. This Act defined the boundary and territory of the District as follows: "all that territory of the County of Tehama lying within the exterior boundaries thereof." In the context of this RFMP, Tehama County FCWCD is responsible for the maintenance of approximately 13.6 miles of SPFC levees along Deer Creek and Elder Creek. The Deer Creek levees primarily protect rural agricultural lands in addition to the rural area of Vina. Elder Creek levees protect the small community of Gerber in addition to rural agricultural areas.

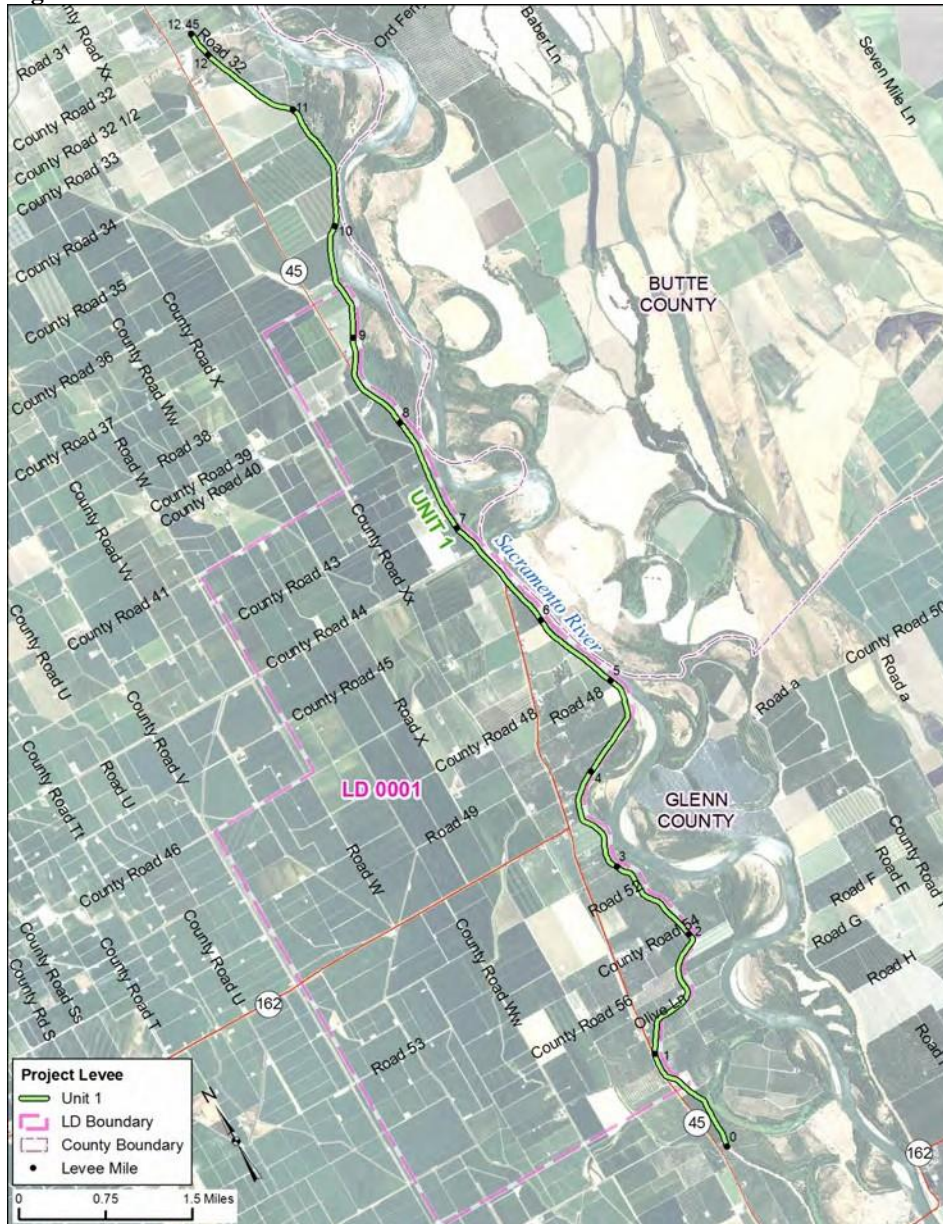
Figure 9-4. Overview of LD 1 SPFC Facilities

Levee District 1 (LD1) maintains 12.45 miles of SPFC levee along the right bank of the Sacramento River.

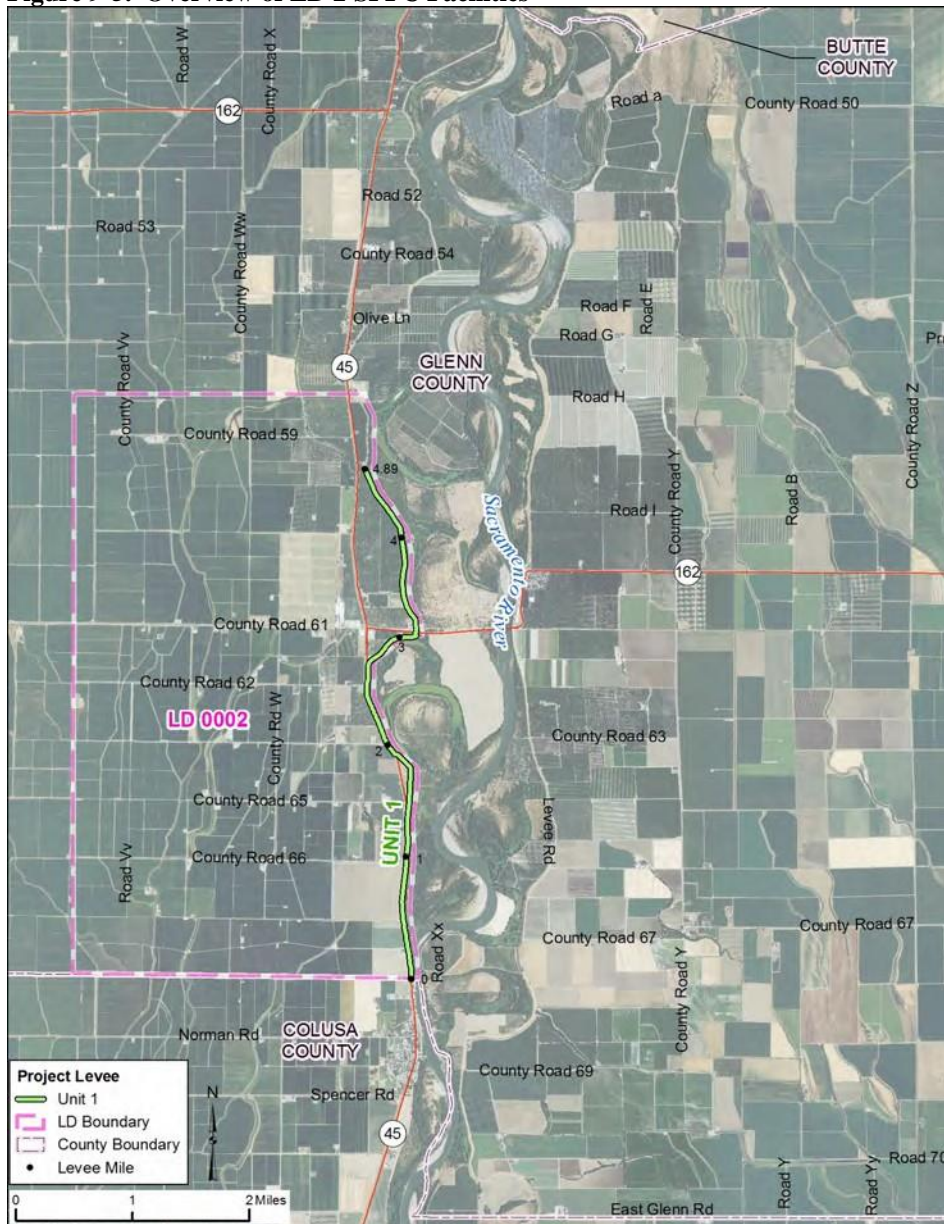
Figure 9-5. Overview of LD 2 SPFC Facilities

Levee District 2 (LD 2) maintains 4.9 miles of SPFC levee along the right bank of the Sacramento River.

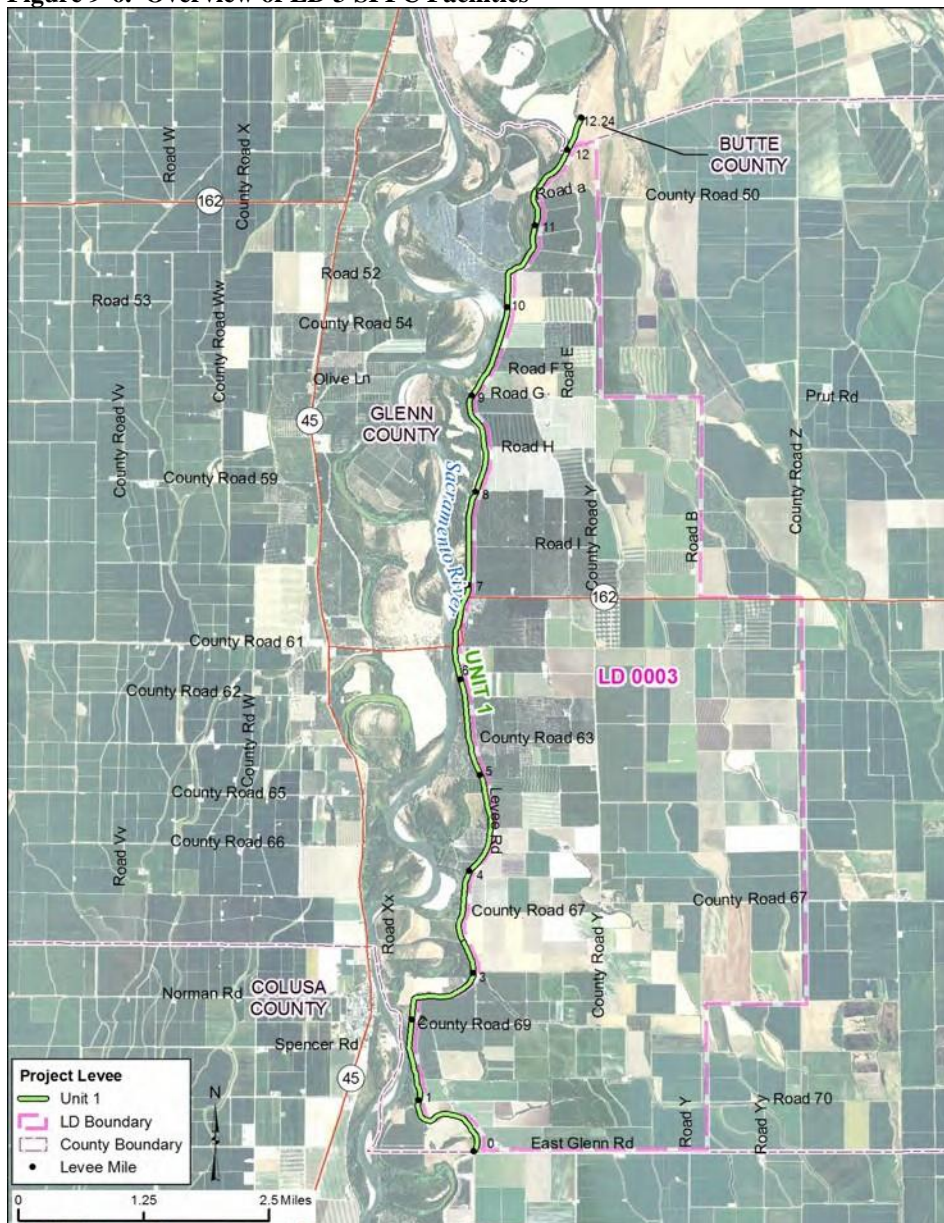
Figure 9-6. Overview of LD 3 SPFC Facilities

Levee District 3 (LD 3) maintains 12.25 miles of SPFC levee along the left bank of the Sacramento River.

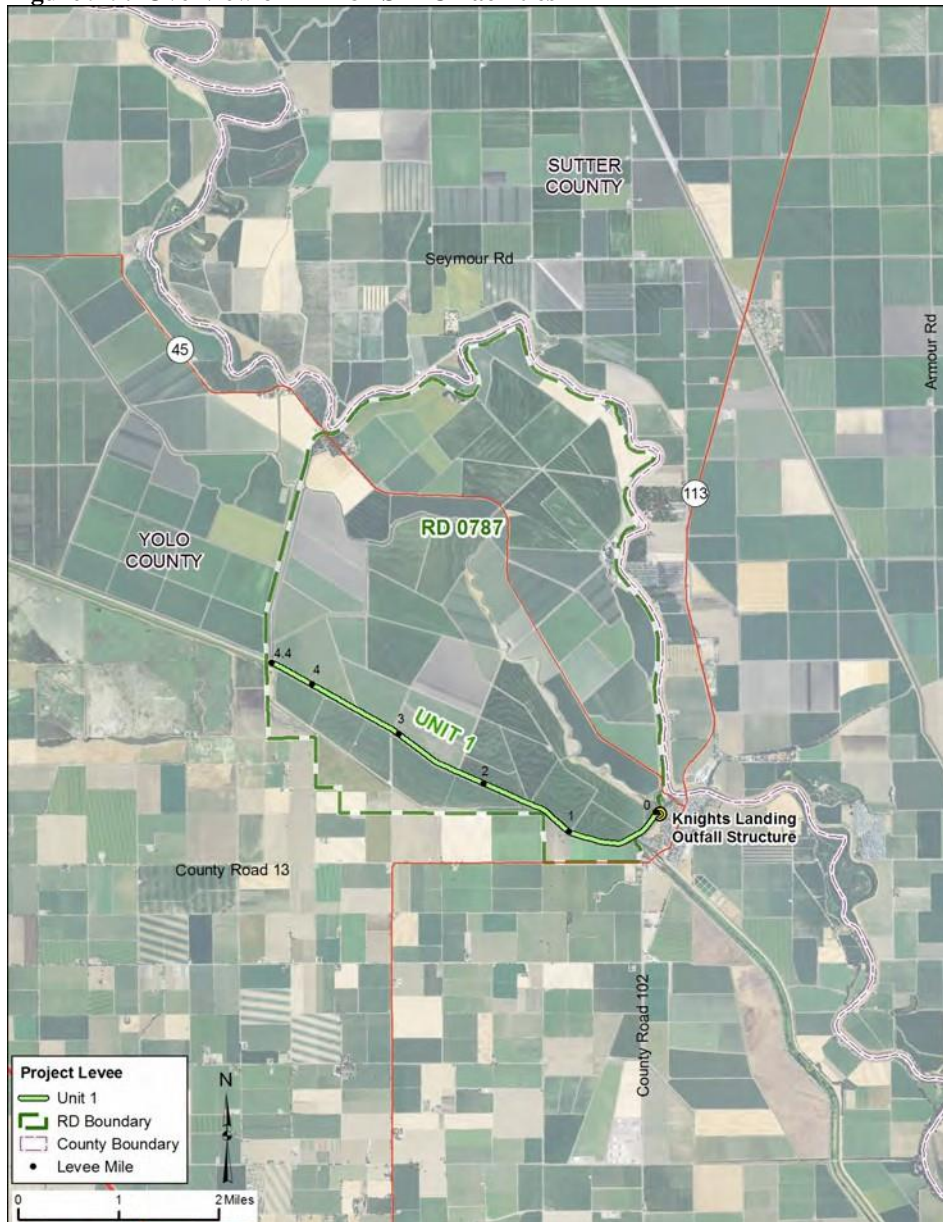
Figure 9-9. Overview of RD 787 SPFC Facilities

Reclamation District 787 is located just south of RD 108. Originally, the left bank levee along the Colusa Drain was constructed from local soils and dredged materials from the areas along the existing river channel starting in 1910 through the 1920s. In the 1950's the RD 787 levees were reconstructed using federal funds and were accepted into the federal Sacramento River Flood Control Project. This work was completed in July 1956. Since the late 1950s, RD 787 levees have experienced subsidence, erosion, cracking, and landside slope failure

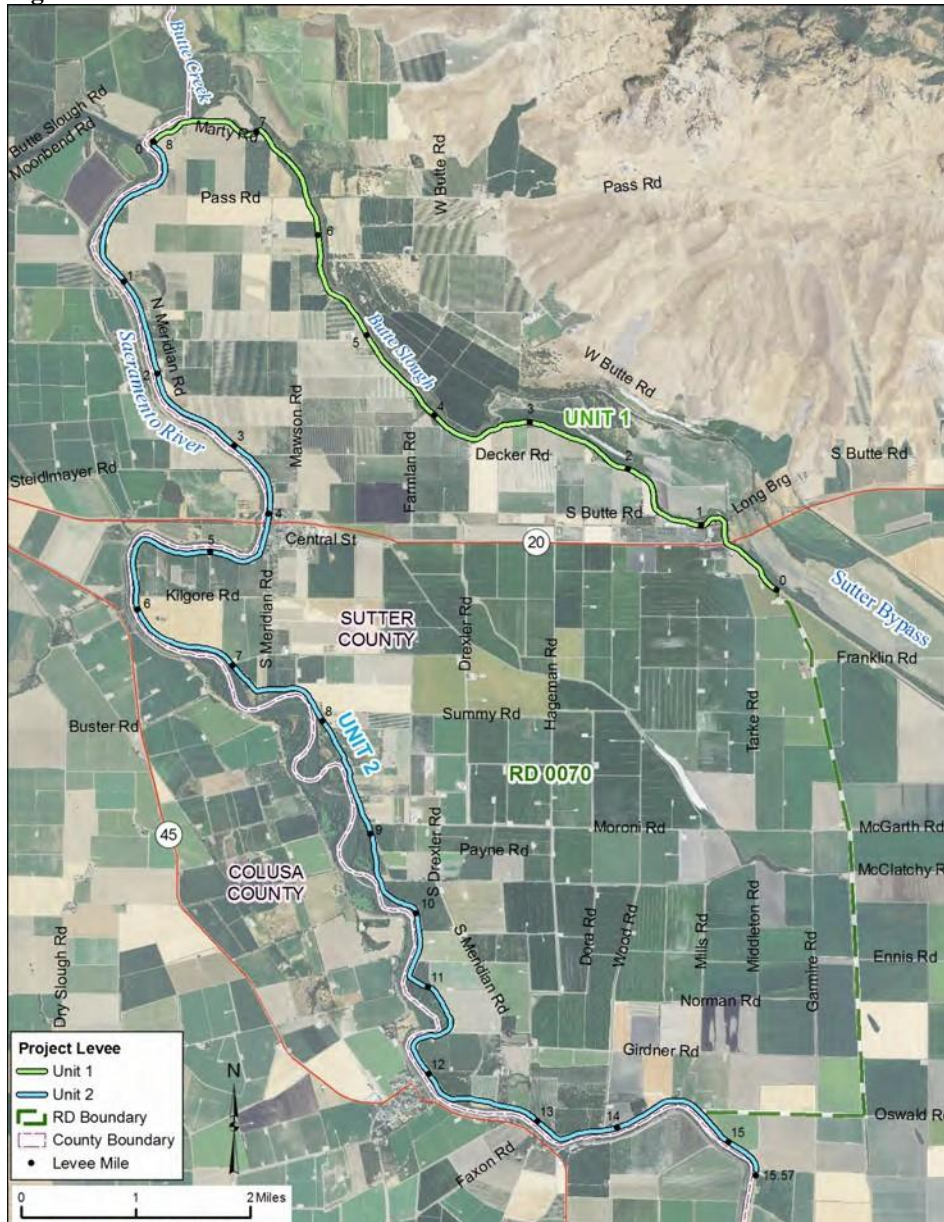
Figure 9-10. Overview of RD 70 SPFC Facilities

Reclamation District (RD) 70 maintains 8 miles of the right bank levee of the Sutter Bypass and 15.8 miles of the left bank levee of the Sacramento River.

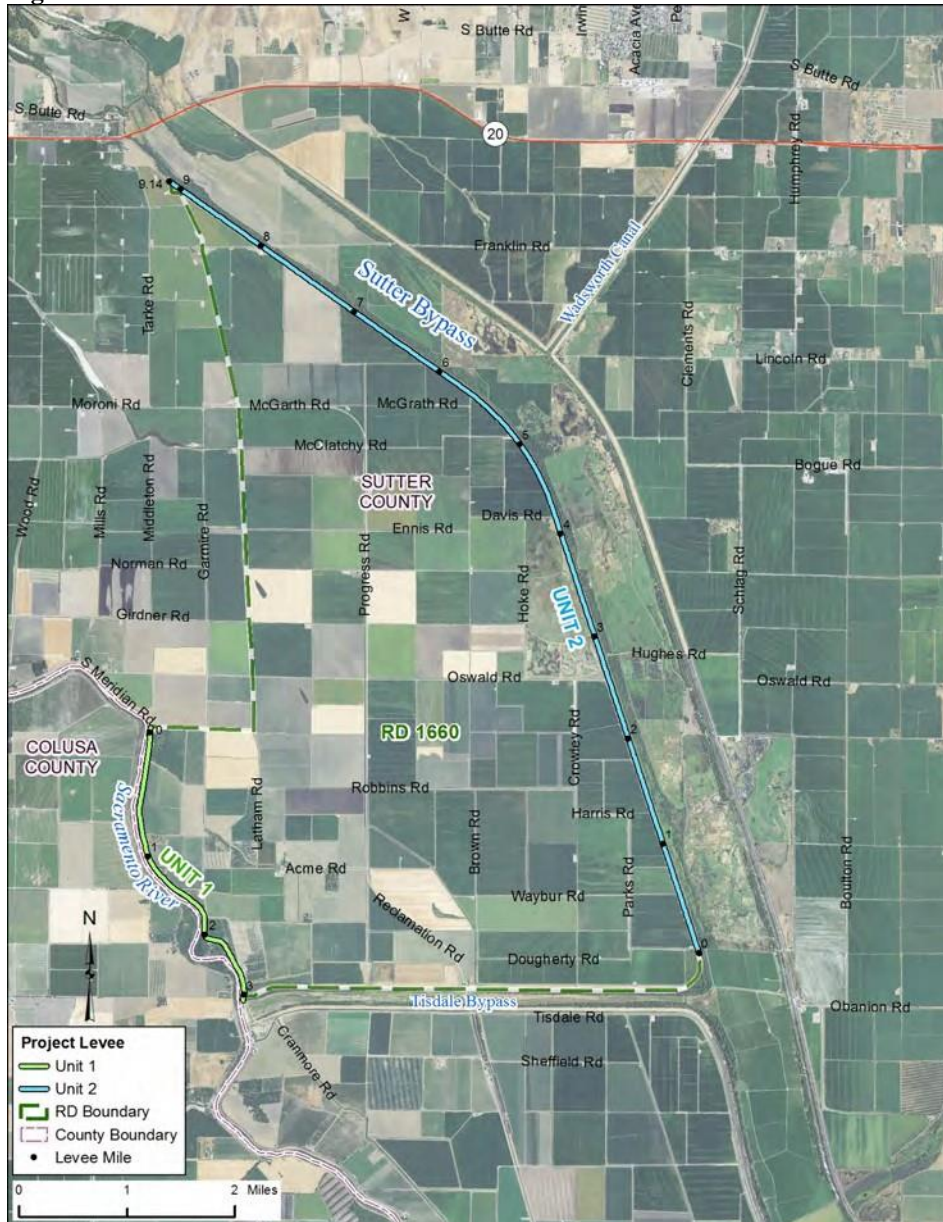
Figure 9-11. Overview of RD 1660 SPFC Facilities

Reclamation District 1660 maintains 9 miles of the right bank levee of the Sutter Bypass and 3 miles of the left bank levee of the Sacramento River.

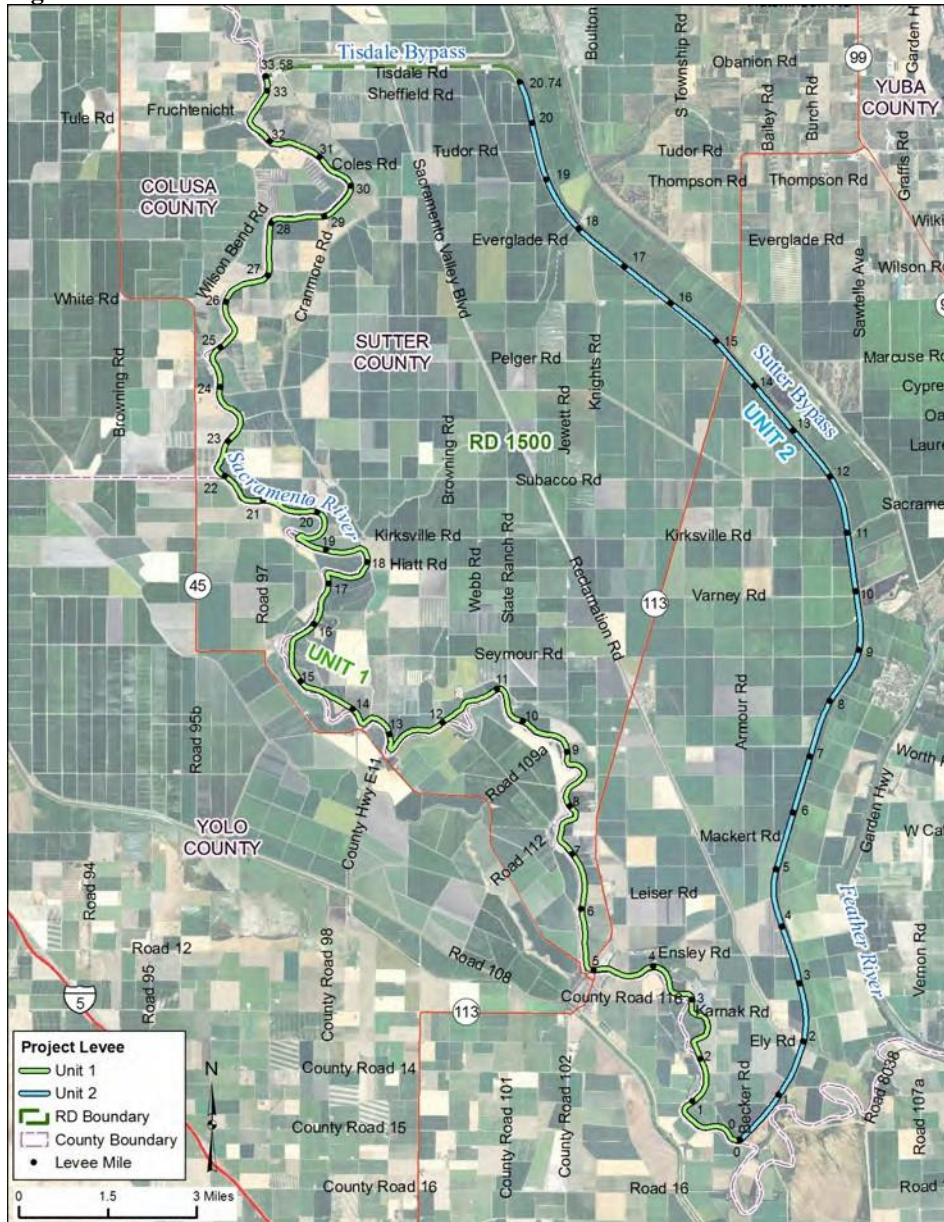
Figure 9-12. Overview of RD 1500 SPFC Facilities

Reclamation District (RD) 1500 maintains 20.8 miles of the right bank levee of the Sutter Bypass and 33.6 miles of the left bank levee of the Sacramento River.

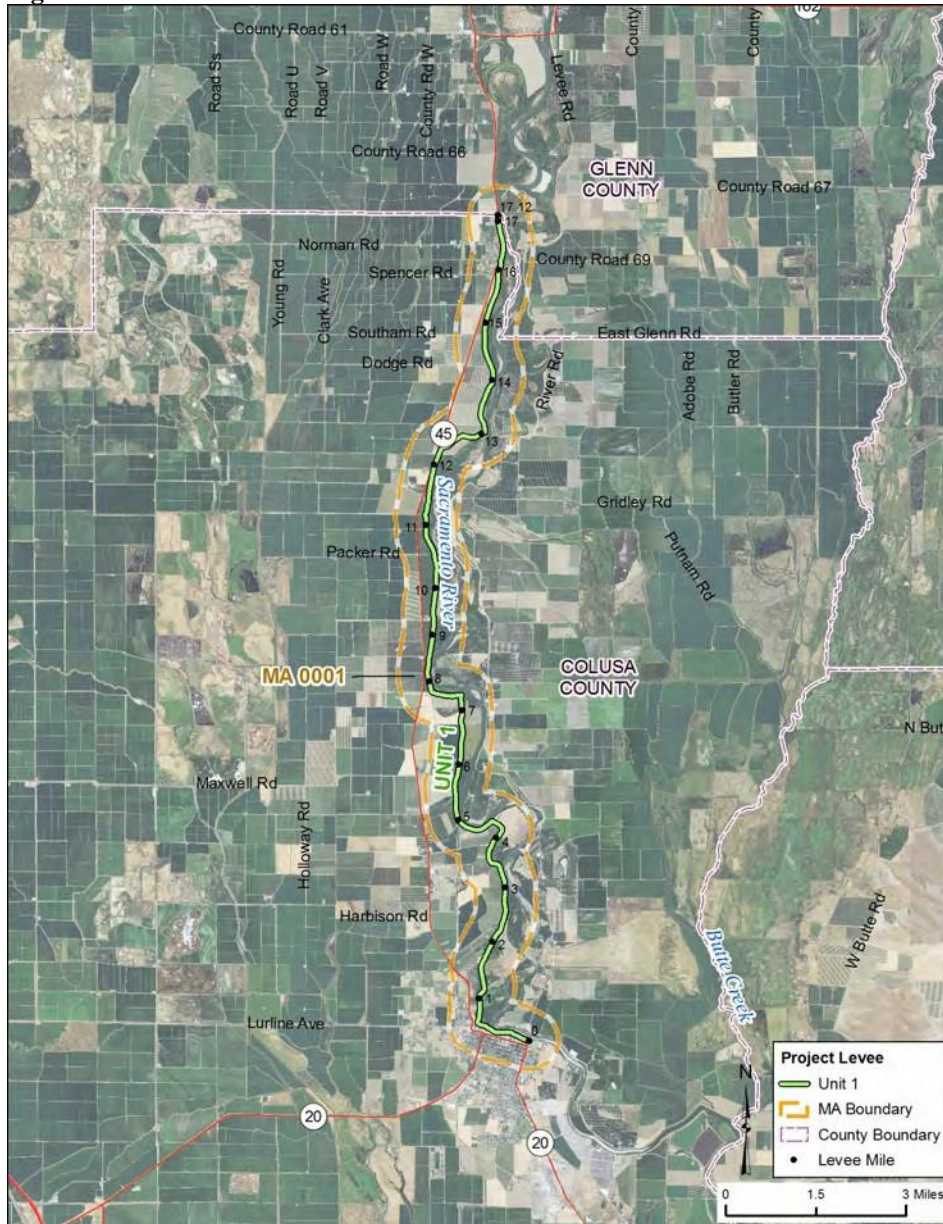
Figure 9-13. Overview of MA 1 SPFC Facilities

Maintenance Area (MA) 1 maintains 17 miles of the right bank levee of the Sacramento River.

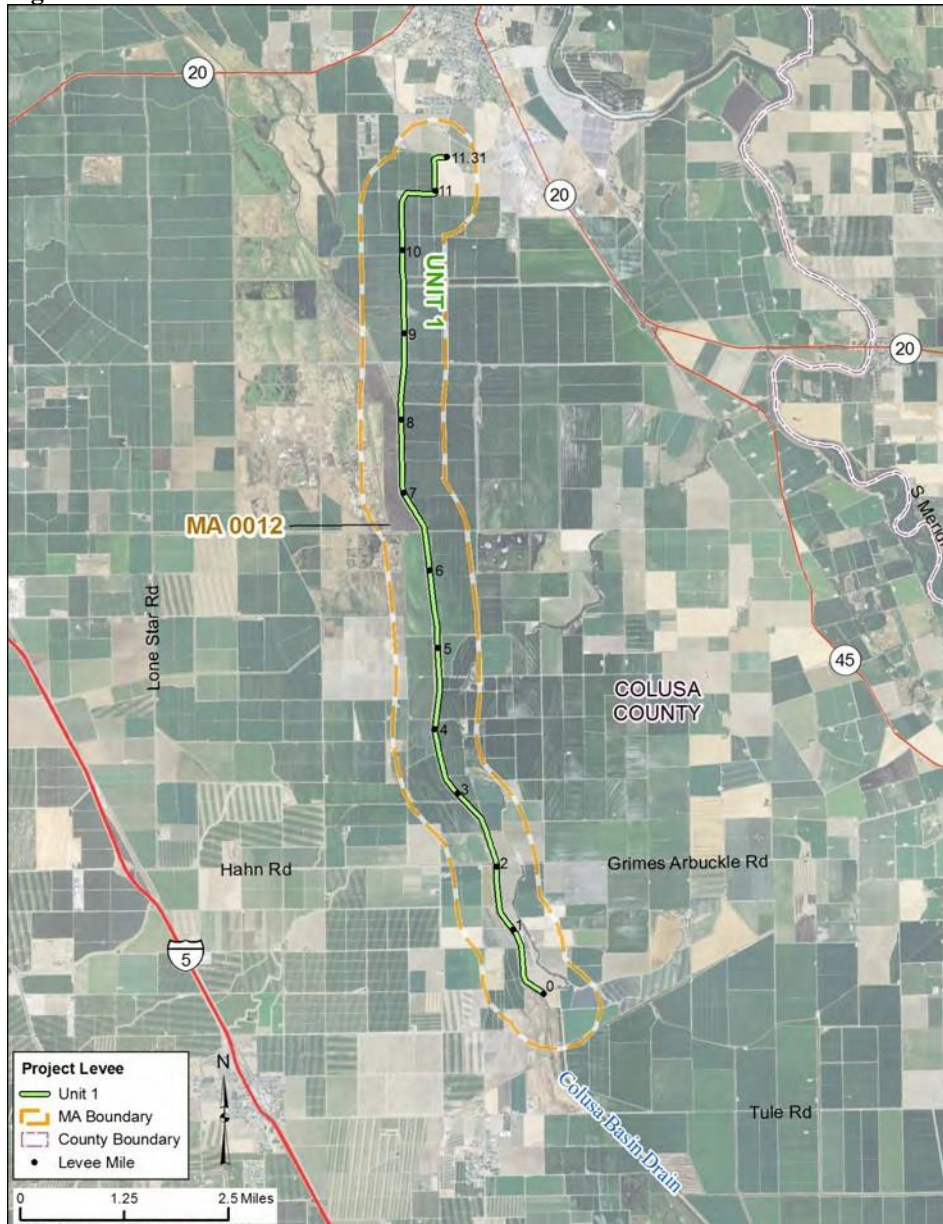
Figure 9-15. Overview of MA 12 SPFC Facilities

Maintenance Area (MA) 12 maintains 11.3 miles of the left bank levee Colusa Basin Drain.

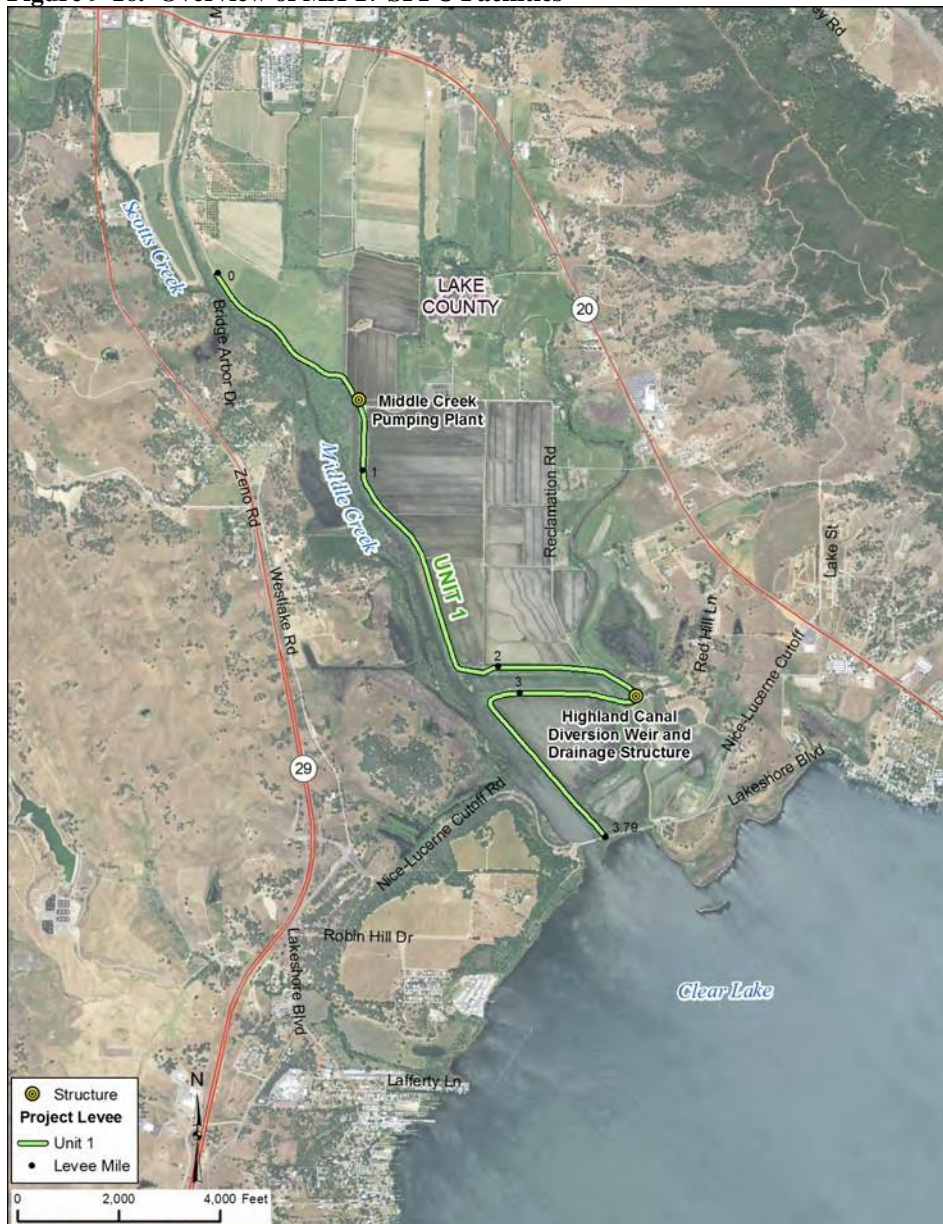
Figure 9-16. Overview of MA 17 SPFC Facilities

Maintenance Area (MA) 17 maintains 3.9 miles of the left bank levee of Middle Creek in Lake County.
